STASS

System Two Assess and Seal Solution

NIA Innovation
Richard Hynes-Cooper (LCNI 2018)

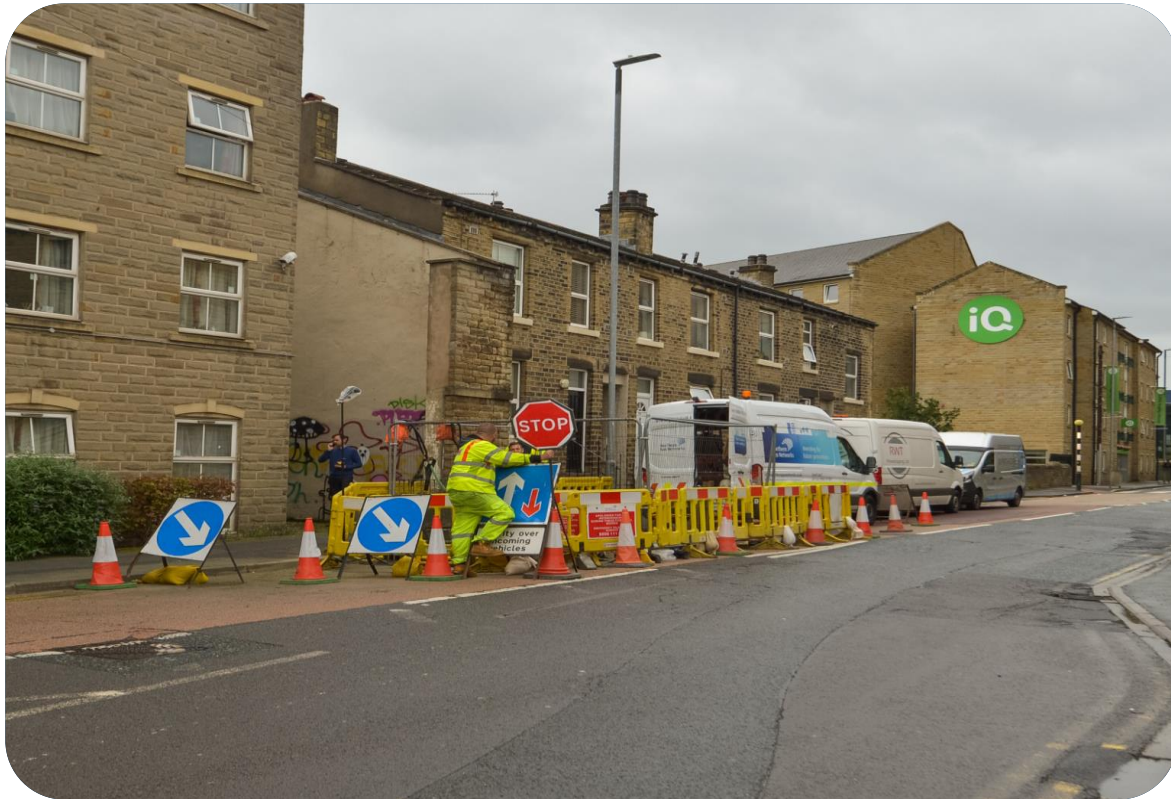
Large diameter mains – Intelligence and leakage

- NGN have 1,700 km of Tier 2 and 3 assets
- Repair or assessment has significant impact and is expensive.
- There are 3 key drivers for intervention in relation to these assets:
 - Leakage identification and repair
 - Proactive risk management
 - Confirmation of as laid data
- During 2015 NGN carried out in excess of 1,100 repairs to large diameter leaking joints.
- The largest population within the Tier 2 to 3 range was 12”, 18” and 24” with associated repair costs circa £5m.

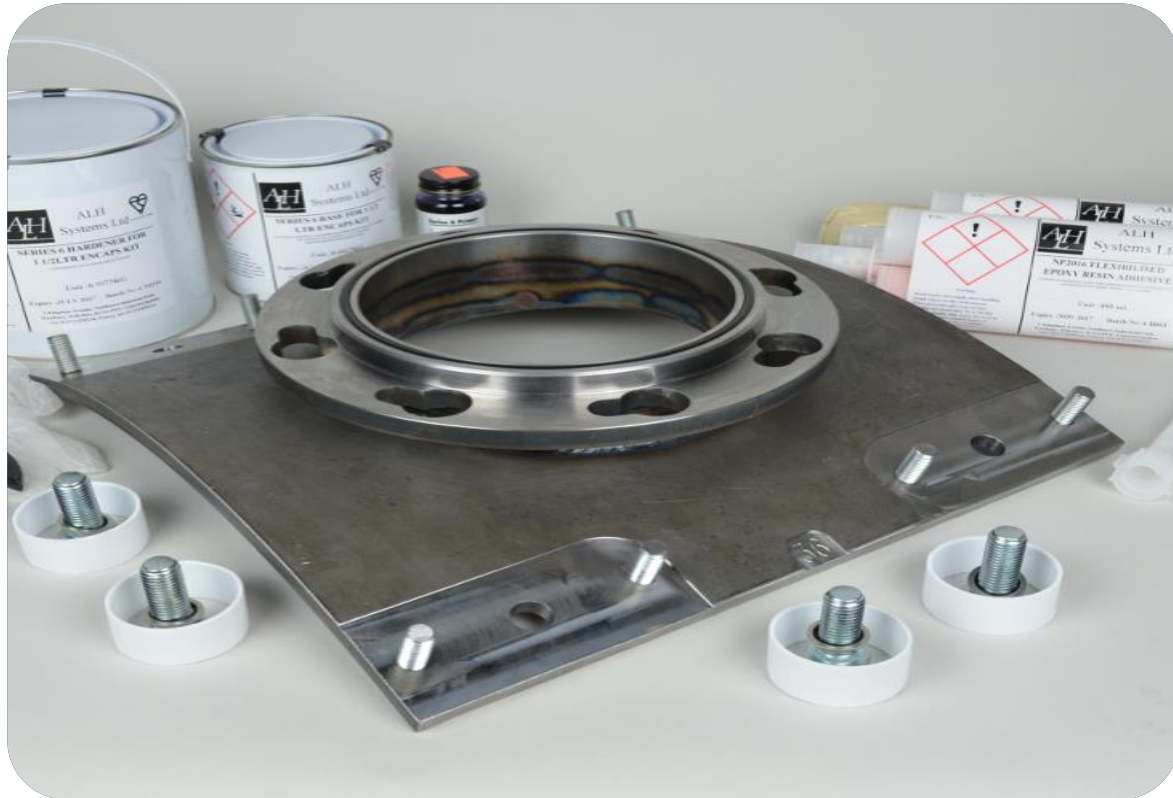
(1) Synthotrax Intelligent Robotic Vehicle (2) ALH Bond and Bolt Technique and (3) ALH Main / Flex-spray LC12 sealants

- **Access** – Single excavation?
- **Distance** – 260 metres?
- **Task** – Pick one????
- **Communication and data capture** – What protocol? How many languages? Storage? (*How much is too much data??*)
- **Operating model** - Development of system that can be operated by NGN direct labour teams to maximise cost benefit.

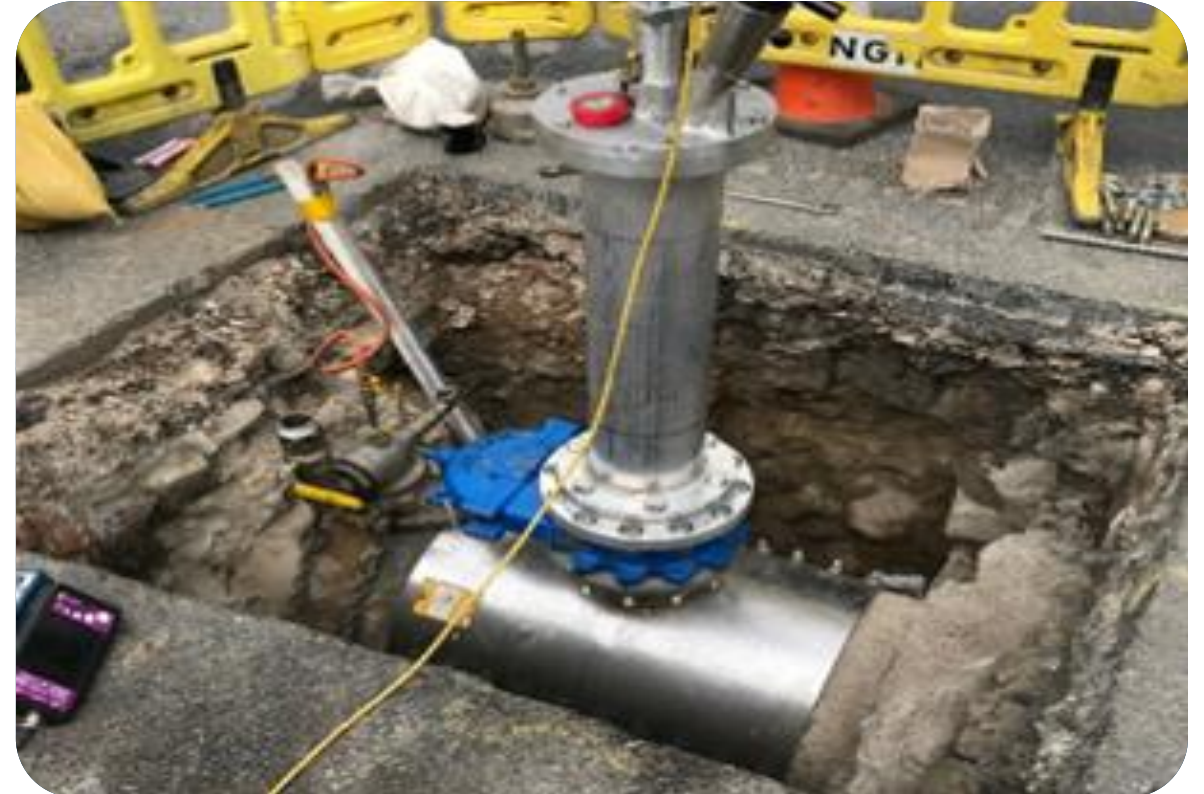
Access:

- Encirclement clamp 12" to 23"
- Bond and Bolt in ≥ 24 " pipe

Treatment:

- Full 360 degree joint spraying (ALH Mainspray)

Identify and locate:

- Targeted feature spraying (point laser)
- Line laser greater aligning and aiming accuracy
- Sonde

Vision:

- One Titan™ Pan and Tilt camera for full circumferential vision
- One fixed front-facing camera
- One fixed rear camera

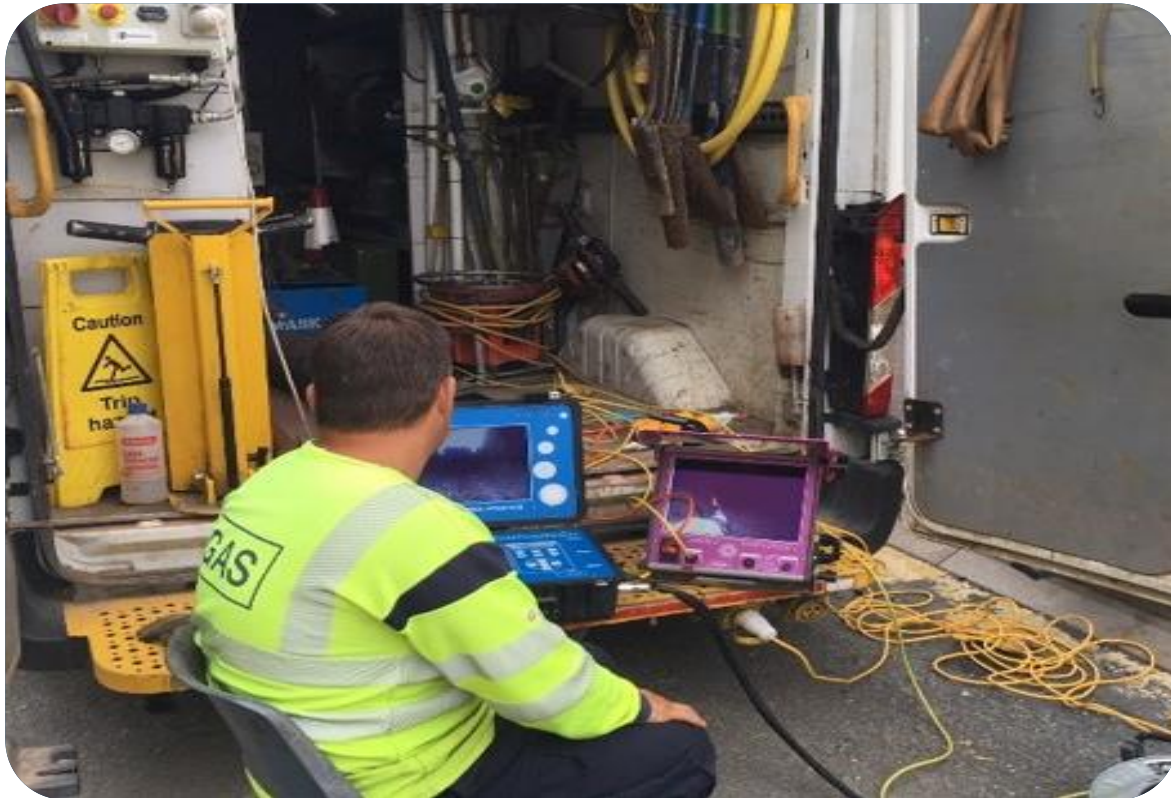
Progress to date - 7 Trials completed

- Variation based on learning, in order meet 100% of objectives, robot B had limitations.
- Confidence gained that Flexspray is resolving leakage – targeted and accurate.
- Provided an Inside out picture of mains & features.
- Sealant deployed on 32 joints in 2 ¼ hrs (average 4 mins Joint to Joint).
- NGN led operation – Not a specialist service.

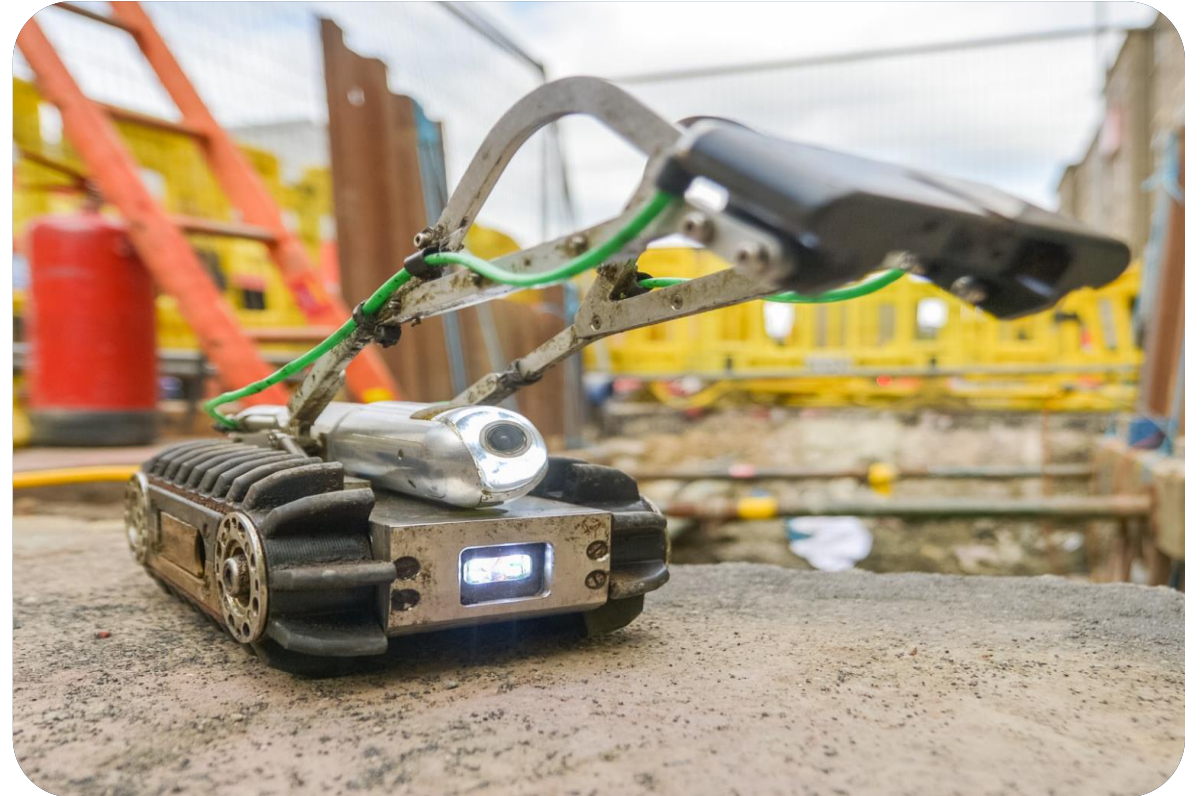
- Significant assessment and design was completed to identify functionality requirements
- The STASS 'long wheel base' design was commissioned.
- These design developments include:
 - New driven wheels
 - Substantial additional weight
 - Drive chains with a tensioning system to meet the needs to the challenge identified

ROBOT A Concept	ROBOT B (SWB)	ROBOT C (LWB)

VISION AND SPRAY LIMITATIONS DRIVE DISTANCE & DEBRIS LIMITATIONS PROTOTYPE	DISTANCE LIMITATION JOINT SPRAYING ONLY WET DEBRIS ISSUE OPTIMISED 12" to 18" 80 -130m TRAVEL	16" & ABOVE VERTICAL LIVE LAUNCH MODULAR DRIVE SYSTEM MULTIPLE WHEELS & CHAIN TRACKS LASER AND SPRAY TARGETER ACTUATED LIFTER INCREASED WEIGHT IMPROVED SONDE ENCLOSURE

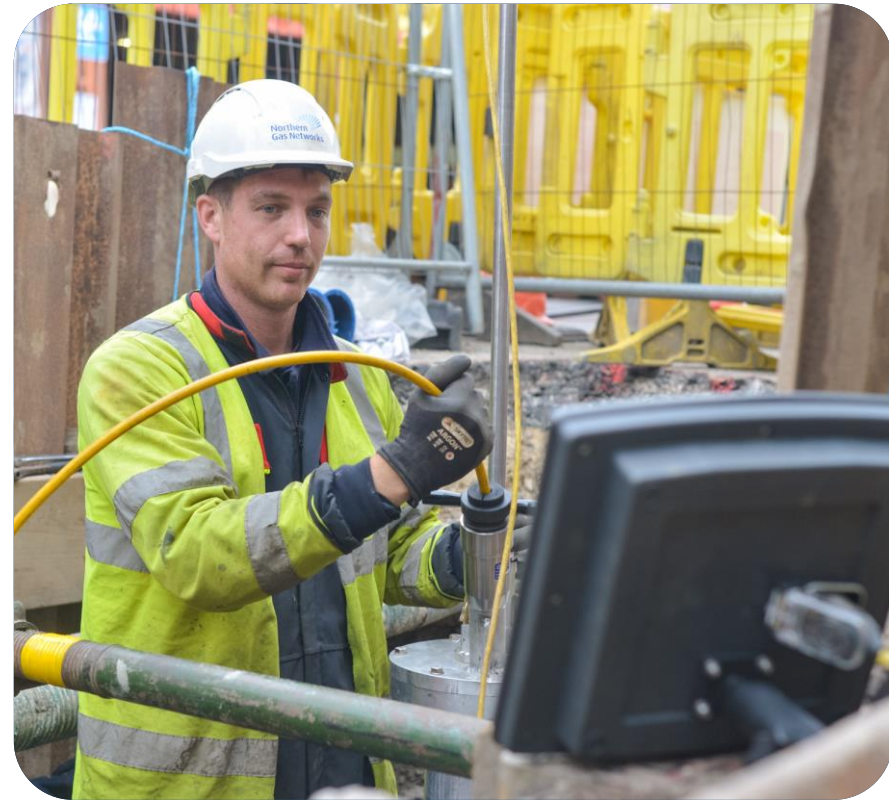
NGN DLO engineers delivered:

- Vertical launch the robot via a Bond and Bolt connection to a 24" main.
- Identification of debris in the bottom of the main.
- Identification of network features such as joints and plugs via in-built Sonde to allow data capture and recording.
- Successful travel of approximately 100m (into the junction of the main road from Huddersfield to Holmfirth without disrupting traffic flow).
- Identification of 'loose lead' becoming detached from the inside of lead yarn joints.
- Identification of clear water ingress into the 24" main and direction of travel of water as it ran into the main.
- Internal main spray treatment of 17 24" lead yarn joints via targeted and precise deployment of 'glow in the dark' sealant which was visible on camera.
